Safeguarding of the Portuguese Heritage: the Case Study of Safi Cathedral, Morocco

ABSTRACT: The city of Safi is located in the West African coast, about 150 km from the city of Marrakesh and 300 km south of Casablanca, Morocco. The Cathedral of Safi was the first Portuguese cathedral outside Portugal during the Expansion period and it is the most important example of the non-military Manueline architecture that still remains outside Portugal. The construction of the cathedral started during the decade of 1520. It was originally a three nave church and is believed to be similar to other temples of the time such as the Funchal or Guarda Cathedrals. During its history, the cathedral was occupied by Muslims who eliminated the naves, leaving only the main altar, one lateral chapel and an outside wall. The space of the naves was used to add several residential buildings and they turned the altar in a bathhouse for women (hammam in Arab). The altar, crowned by a ribbed vault, the lateral chapel whose roof, also vaulted, is missing and one alone standing external wall are the only original parts of the structure that are left. The Cathedral will be soon submitted to a structural interven

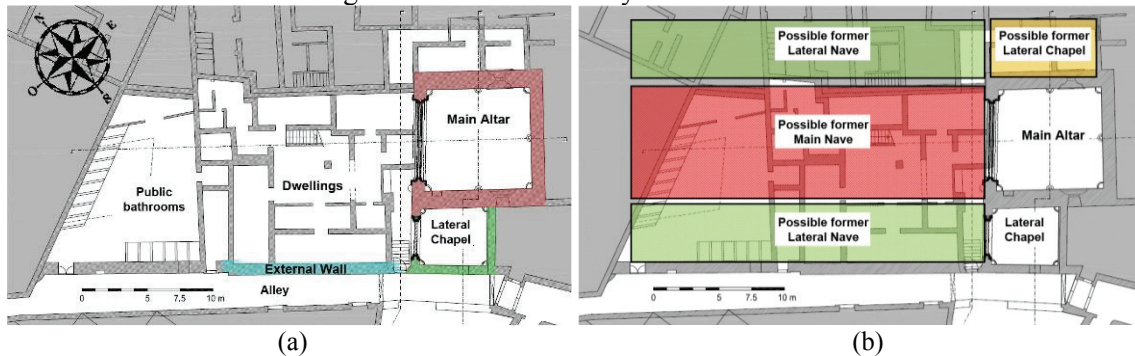
Figure 2: Plant of Cathedral [2]: (a) Plant of street level of the existing structures; (b) Possible former outline of the original Cathedral.

Because the cathedral was built in the same period as the Funchal cathedral, it is believed that the Safi Cathedral had a similar structural organization. In this case, the Safi cathedral would have been an arrangement of three naves and two lateral chapels, covered by a light wooden roof. Figure 2a shows the actual structural configuration of the remaining Cathedral (colored areas), the adjacent structures and the probable original configuration is presented in Figure 2b. A brief description of the Funchal cathedral is given in the next Section, in order to give the reader an idea of how the original Safi Cathedral may have looked like.

As it was shown in Figure 2, the space that belonged to the naves is today occupied by dwellings with thick stone masonry walls, concrete pavements and is covered with wooden roof-terrace structures. Also a big public bath and toilets are available in that zone.

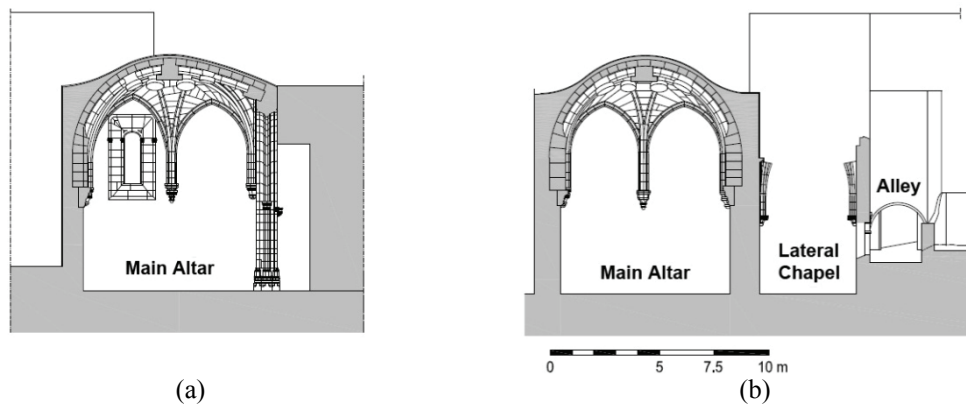
Figure 3: Elevations of Cathedral: (a) Elevation of main chapel in north-east direction; and (b) elevation of main chapel and lateral chapel in south-east direction.

Figure 3 shows an elevation of the original remains of the main chapel with its ribbed vault, and the lateral chapel, now without vault. It also can be appreciated in this figure, that the level of the alley is 1.4 m higher than the pavement of the Cathedral. This is very usual in old cities, since the cities have been built progressively over time. Therefore, streets and alleys are mainly composed of infill material which has accumulated over centuries. Finally, these old streets and alleys can be up to some meters over the level of the former ground floors.

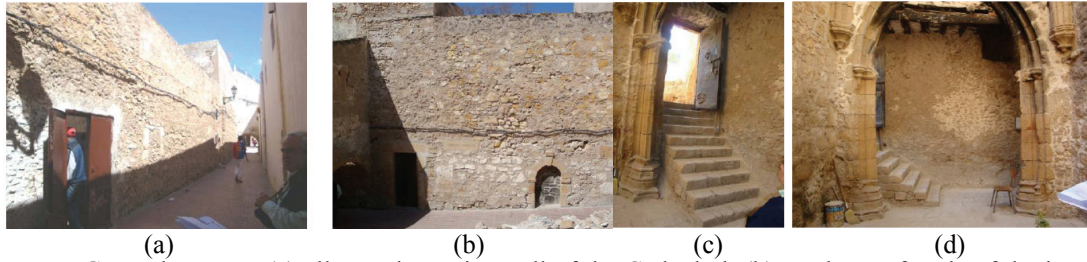
Figure 5: General aspects: (a) alley and exterior wall of the Cathedral; (b) north-east façade of the lateral chapel; (c) present entrance to the ruins of the cathedral, through the lateral chapel; and (d) view of the lateral chapel in the direction of the former nave.

In Figure 5 general aspects of the Cathedral are shown. The alley that limits with the Cathedral is shown in Figure 5a. It presents the left side of the exterior wall of the Cathedral that can be seen from the Grand Mosque of Safi. The entrance of the cathedral is shown in Figure 5b and c. Again, a difference between the level of the street and the pavement of the ground floor of the Cathedral can be observed. In Figure 5d the lateral chapel is shown. The view is in the north-west direction in which (probably) the naves of the Cathedral were placed. This arch was not closed with a masonry wall like the main chapel was.
